# Manhole Inspection Summary

Manhole # S37MM\_013MH

Insp Date: **2/2/07 11:03 AM**

**Location** Address: **2110 HOMEWOOD AVE**

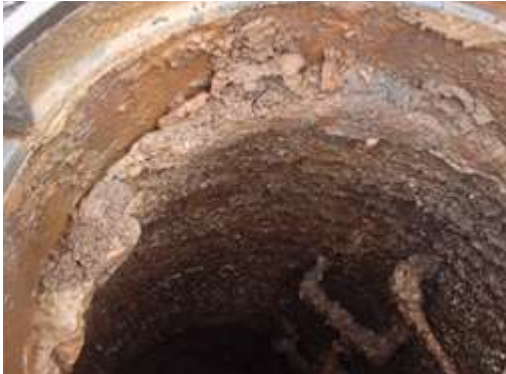
Defect

☒ **Debris** (not Condition related)

☒ **Corroded**

☒ **Evidence Of Surcharge**

Depth: **5**

Corroded steps. Evidence of surcharge - Bench debris.

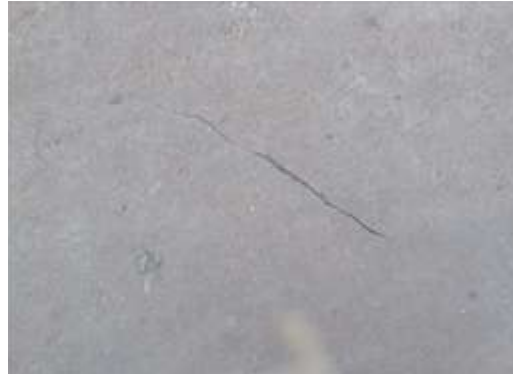
Defect

Offset: **1** (in.)

☒ **Leaks**

Condition: ☐ Sound ☐ Cracked ☐ Root Intrusion ☐ Loose Brick ☒ **Deteriorated**

Infiltration: ☐ None ☒ **Joint** ☐ Cracks ☐ Mortar ☐ Roots ☒ **Wall**

Frame leaks. Frame offset. Adjustment deterioration and infiltration.
